# Using New Techniques of Geomatics and Structural Control in the Old City Center of L'Aquila after the June 6, 2009 Earthquake

D. Dominici<sup>b</sup>, D. Galeota<sup>a</sup>, A. Gregori<sup>a</sup>, E. Rosciano<sup>a</sup>, M. Elaiopoulos<sup>b</sup>

**KEY WORDS:** Post earthquake structural monitoring, Geomatics, Topographic Survey, NDTM, Thermography.

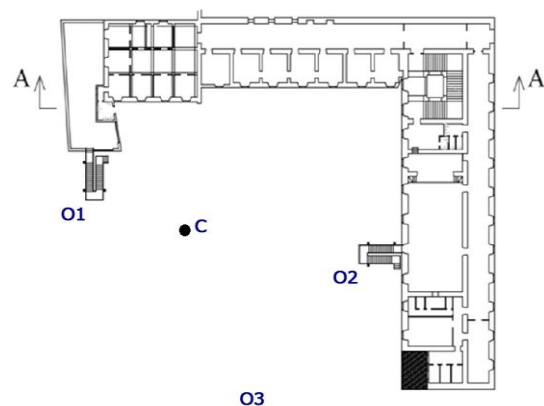
Figure 3. Palazzo Camponeschi plan: spot C represents the location of total station; spots O1, O2, O3 represent reference points.

In order to recognize the signs of ongoing kinematism and possible collapse mechanisms, a visual inspection of the structure was first required. Evidence of structural damages was found at any level of both the internal fronts of the building, so that a grid of 27 points distributed along 9 vertical alignments and 3 rows was decided as monitoring network. In particular, grid's columns were made to correspond to selected vertical alignments of window along the buildings fronts, and the grid's rows to the internal building floors respectively. Figure 6 shows the distribution of the 27 control points: note the grid spacing was reduced to better investigate the possible overturning of the middle SW facade. In addition, three more points ( $O_1$ ,  $O_2$ , and  $O_3$  respectively) were selected independently from the structure to assume their position invariant and to serve as reference for the local coordinate system orientation (figure 3). Then, a total number of 30 control points finally constitute the designed surveying network.

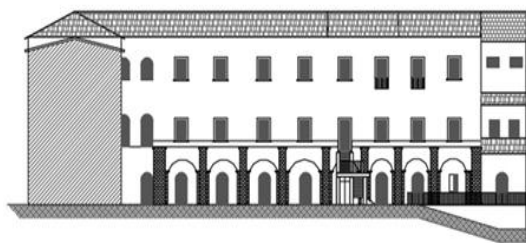
Figure 5. SW and NW internal fronts of the building (facing the courtyard)

The building sits on a sloping site and it consists of three stories, the first of which partially set below the sloping ground level, with the highest fronts measured at the end of the two arms respectively. A traditional gable roof in wood truss, secondary wood elements, planking and brick tiles covers the buildings on top. Along the public road, the building' south-east facade presents a regular vertical and horizontal distribution of two orders of rectangular windows and an arched portal on the right side (Figure 4). At the basement, the internal fronts facing the internal courtyard are characterized by regular arches supported by masonry columns (Figure 5).

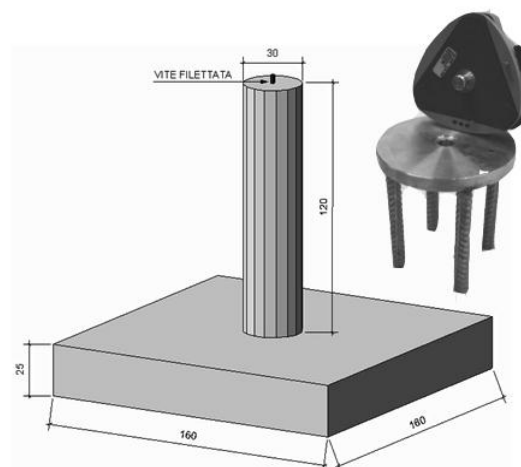
Figure 8. Reinforced concrete pillar layout and view of the still base.

Monitoring a number of 30 points within an under-millimetric precision is not a simple operation. The correct positioning and orientation of the total station, the high quality of all measurements and a careful data elaboration are all crucial parts for the final result. To guarantee perfect positioning and orientation of the instrument a concrete pillar with notable dimensions and a deep foundation was constructed, moreover three mini reflectors have been installed in stable constructions of the surrounding area to be used as orientation points. Before each set of measurements the total station is placed on its special steel base attached to the pillar (figure 8). An accurate orientation is obtained both by surveying the three auxiliary reflectors and by attributing the correct coordinates of two extra points of the surface decided by a separated survey. An even further stability control of the central pilaster's position is obtained by a geomatic triangulation using a GPS measurement. Three permanent GPS receivers, well distributed in the city's space to form a possibly isosceles triangle are used on a static GPS measurement to ensure that the hypothesized stable points remain steady over time. In this way the correct positioning of the three-dimensional reference system on which all coordinates will be placed is guaranteed.

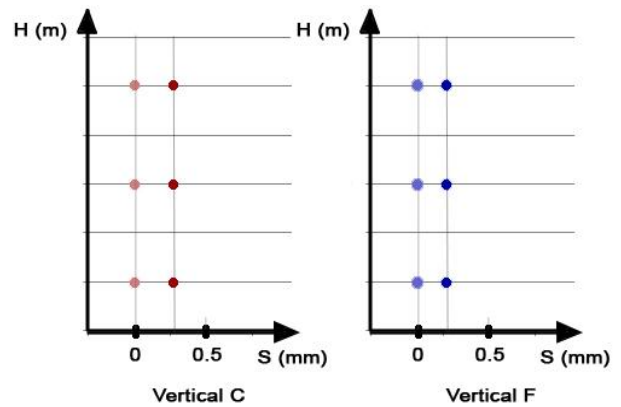
Figure 9.No evidence of displacement for monitoring points belonging to verticals C and F in Figure 6

In this project, the first correct position of each point is registered after the testing period of the whole surveying network. This set of measurements, called zero circle, is now used in order to estimate each movement. The first results already gives an idea on structures' dimensions and state during the hot months of this year. All these information are expected to be used in order to draw the whole situation after the seasonal change and the temperature reduction on near future. In this way a complete imagine of the whole structure is drawn to permit a careful estimation of every possible future deformation. Graph in figure 9 represents the displacements recorded for the tree point aligned on vertical C of figure 6: no evidence of a specific trend was recognized, probably due to the short time period of observation and proving, so far,

effectiveness of the scaffolding and prop mounted into the building to stabilise the structures against future minor earthquakes.

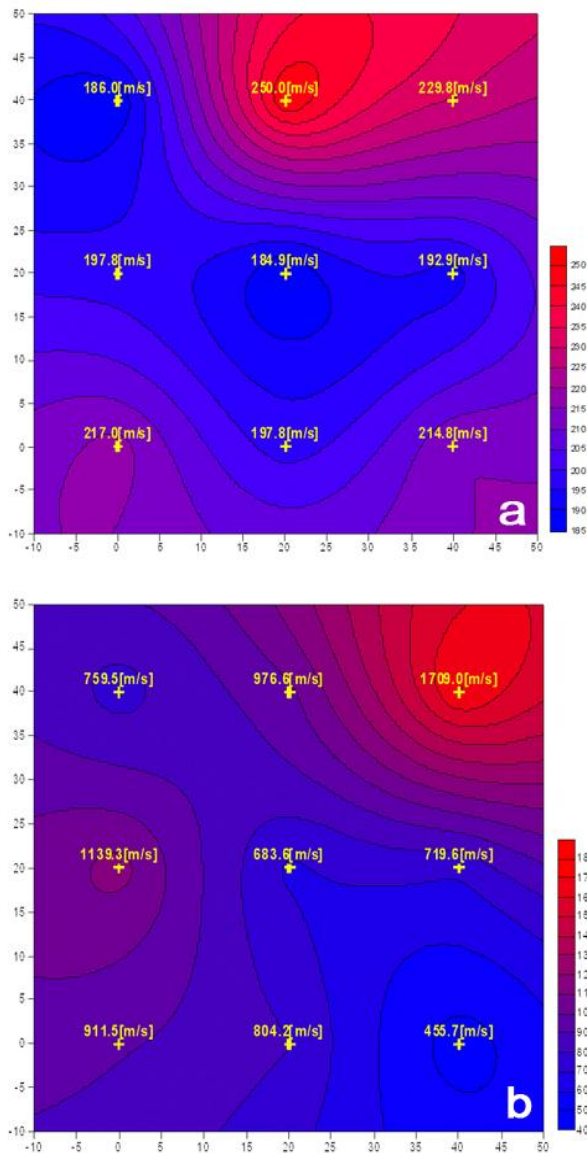
Figure 11. Sound Pulse Velocity Tests: lower velocity values in graph a) correspond to less dense and probably weaker masonry than in graph b). Values dispersion indicate masonry were inhomogeneous in both cases a) and b).

This information were useful in selecting the grid spacing when deciding the survey network, focusing on that part of the buildings front potentially less stable. On the other hand, measuring the sound pulses velocity in traversing the wall thickness allows to evaluate homogeneity of the masonry in its volume and quality of the walls in their thickness. Graphs in Figure 11 report the results obtained from SPVT performed on different representative portions of the SW front of the building, at the first wall elevation above the ground level. Different values of the pulse velocity are reported in the two pictures, and two representative average velocity values can be computed, so that two different masonry types are recognized (less dense and probably weaker the former, more dense and probably stronger the latter). Moreover, variability of the pulse velocity found in different points of the same picture highlight the inhomogeneous nature of the masonry in the wall thickness (in both the graphs).

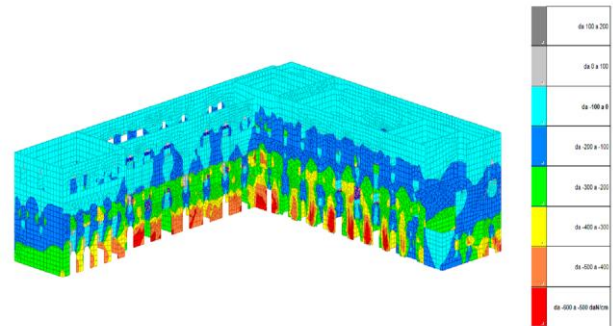
Figure 12. Stress concentration in structural elements resulting from an elastic analysis of the building.

Such information are useful in predicting global and local response of structure to seismic actions, helping calibrating material properties when defining numerical models of the building. Once masonry quality is well known in all part of the building structure, elastic and dynamic analyses of the building are possible at the computer. Figure 12 shows the graphic results from elastic analysis carried out to evaluate stress concentration in the structures under vertical loads.

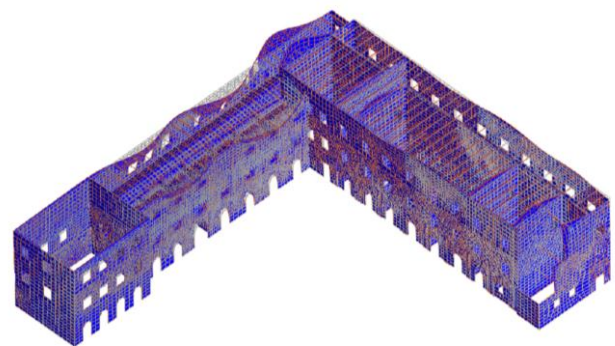
Figure 14. Global and local modal properties of the structure.

Some hypothesis on global and local modal properties of the building are reported in figure 14: part of the structure characterised by a poor connections among orthogonal masonry walls, reduced floors stiffness, wrong mass distribution and absence of restrains to wall overturning were recognized as causes for possible local or global collapse in the building to be monitored.
